**ANALYSIS OF FIELD PERMEABILITY AND LABORATORY
SHEAR STRESSES FOR WESTERN KENTUCKY PARKWAY
MILEPOST 18.240 TO MILEPOST 25.565
CALDWELL-HOPKINS COUNTIES**

Research Report
KTC-03-05/SPR245-02-11

**Analysis of Field Permeability and Laboratory Shear Stresses for
Western Kentucky Parkway
Milepost 18.240 to Milepost 25.565
Caldwell-Hopkins Counties**

February 2003

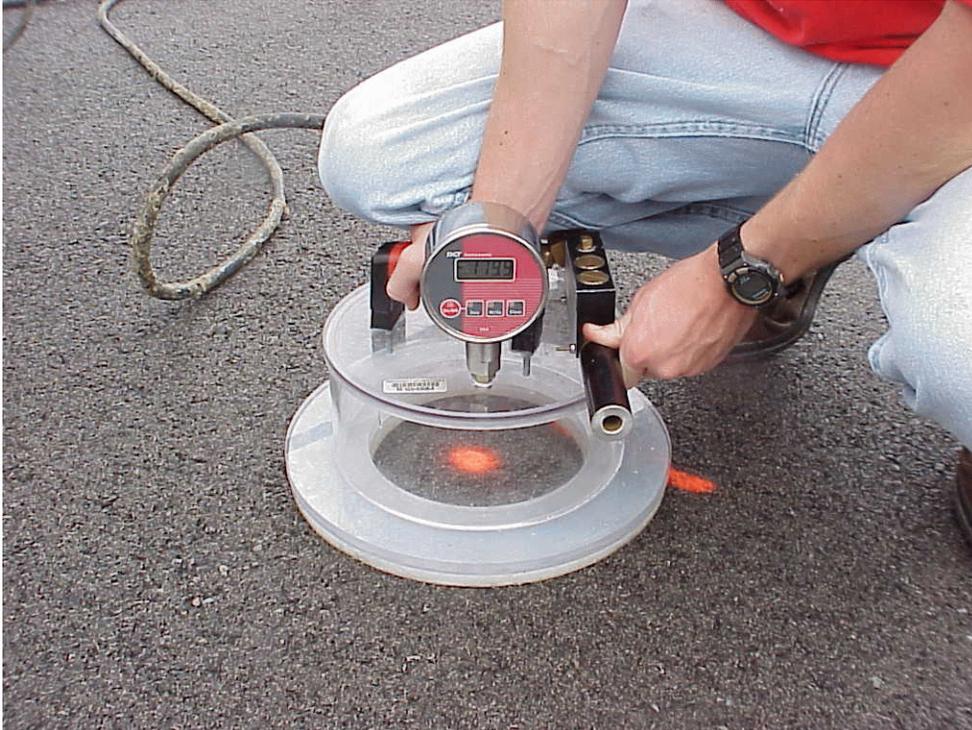
As previously stated, six permeability tests were performed in the field using the AIP device developed at the Transportation Center. Figure 1 shows the device in operation.

Figure 1. AIP Permeameter in Operation.

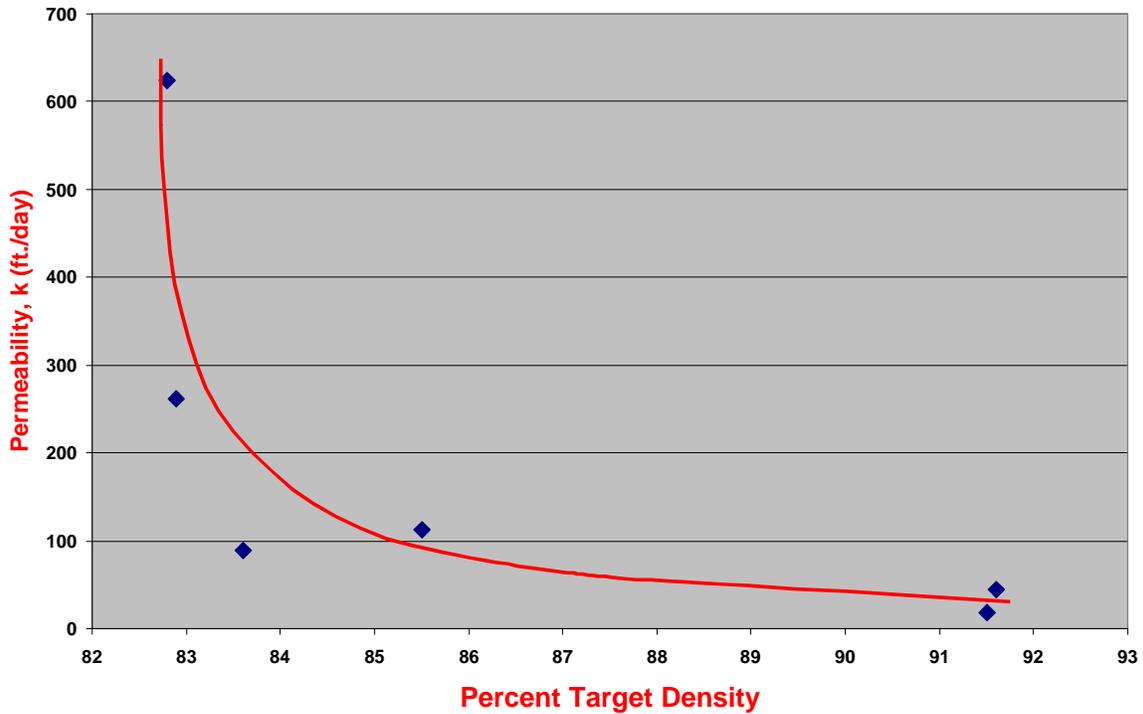
Figure 2. is a graphical representation of the results listed in Table 2. From Figure 2, it is clear that the permeability of the asphalt mat is highly dependent on the density. Those locations that fail the density requirement clearly have a much higher permeability than those that pass the minimum density requirement.

Figure 2. Permeability as a Function of Target Density.

- ! The pavement permeability is highly dependent on the target density. The Densities that were less than the minimum of 90 percent had much higher permeability than the locations where the densities were above the minimum. Experience has shown that pavements with high permeabilities tend to have more problems with stripping and raveling. It is suspected that this pavement will have a shortened service life because of these high permeabilities.

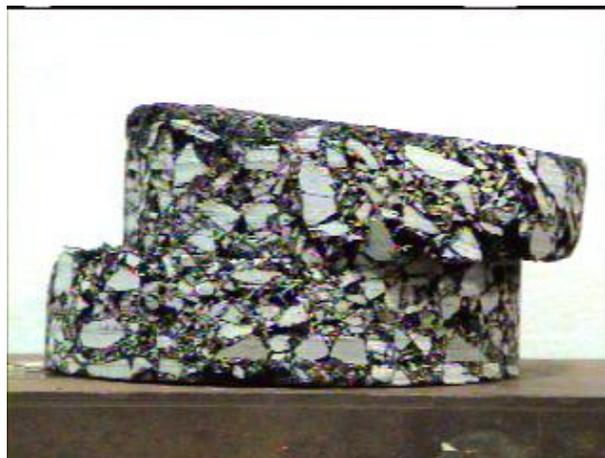
Cores of the surface material that were collected in the field were tested in the laboratory in direct shear mode. A modified Karol-Warner direct shear box was used. The samples were tested in an environmental chamber at a constant temperature of 104 °F. The samples were preconditioned for 24 hours at that temperature. Figure 3 shows the shear sample after testing. Figure 4 shows the testing setup.

Figure 3. Sample After Testing

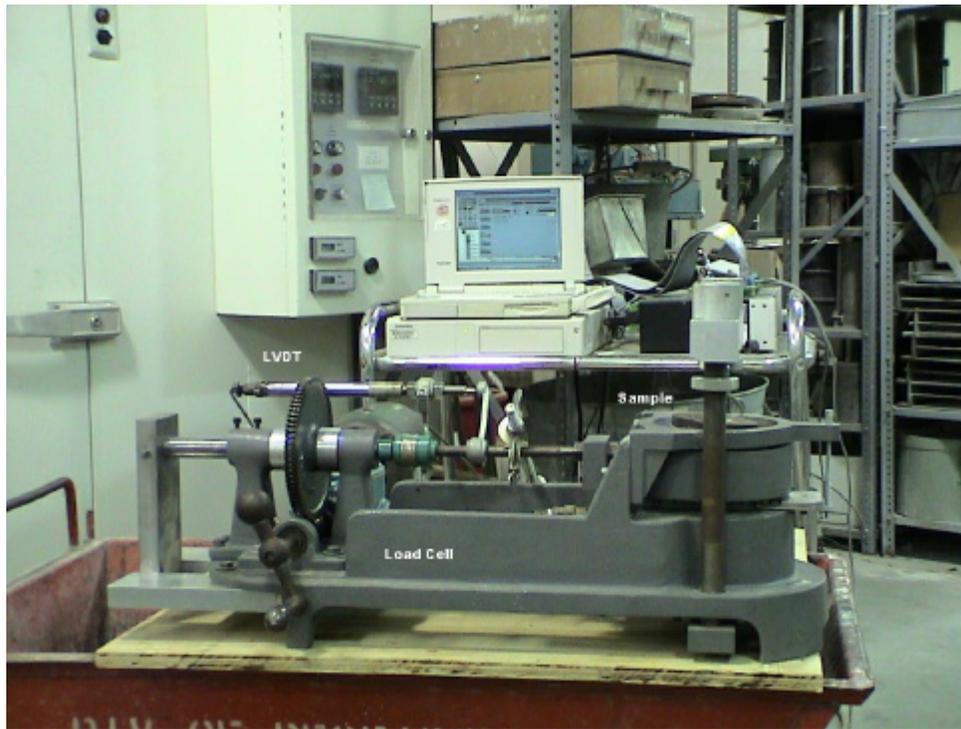
Figure 4. Setup of Testing apparatus.

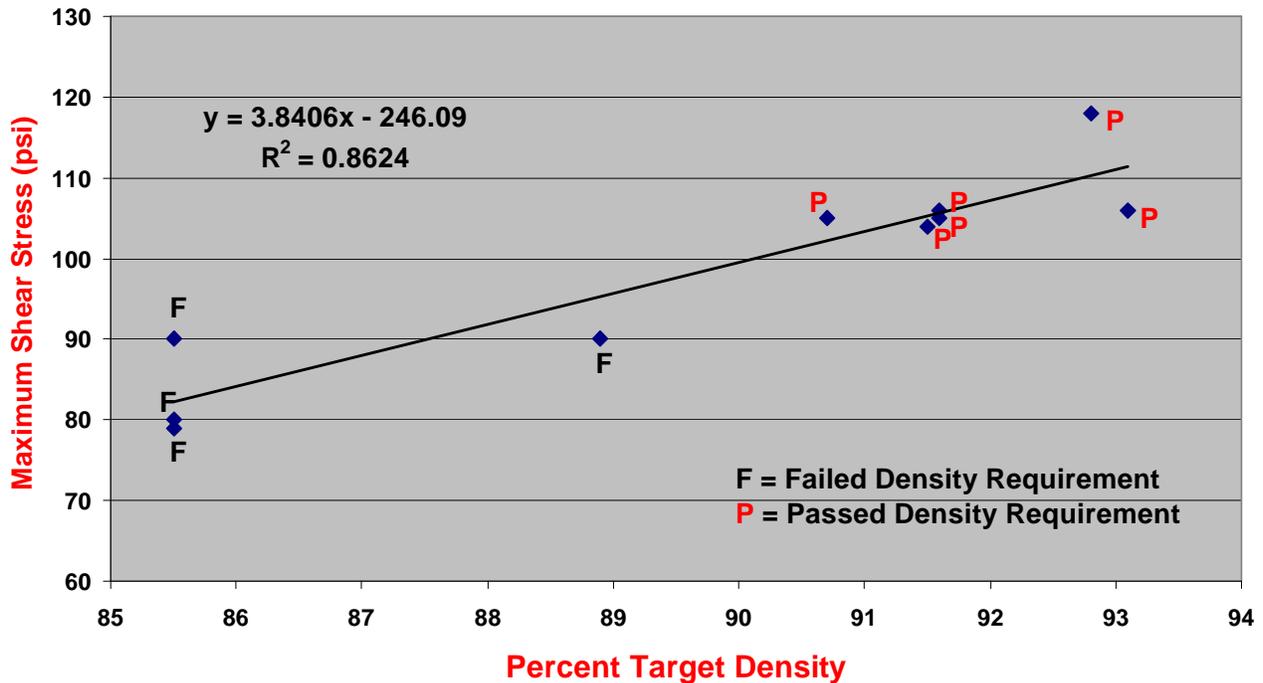
The results of the shear tests are listed in Table 3 and are shown in Figure 5.

Figure 5. Results of Laboratory Shear Tests.

The state specification for lane density requires a minimum of 90 percent of target density. If the contractor fails to reach that density, the material is to be removed. Figure 5 shows a good correlation between density and maximum shear stress. All of the tests on samples passing the minimum density requirement showed considerably higher shear strength than the samples that failed in density.

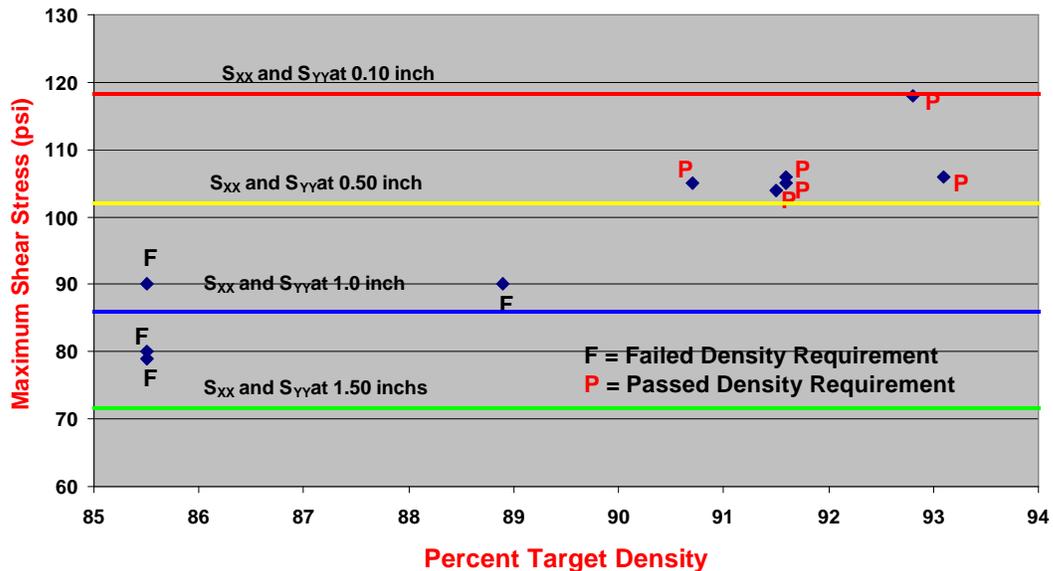
Figure 6 shows the same information as Figure 5 with the exception that the calculated stresses at the various depths are plotted on the graph. That figure shows that the stresses in the horizontal directions (S_{xx} and S_{yy}) and in the vertical direction (S_{zz}) exceed the maximum stresses obtained from the laboratory tests. This indicates that rutting or wheelpath consolidation will most likely be a problem with warmer temperatures.

Figure 6. Comparing Laboratory Stresses with Calculated Horizontal Stresses.

- ! Nearly all (only one exception) of the laboratory shear tests had maximum shear strengths less than the stresses calculated from the layered elastic analysis. This indicates that there is a high probability that rutting will occur on this project and that an excessive amount of consolidation may occur in the wheelpaths.

In view of the data obtained and the analysis conducted in this study, and in view of the information contained in the Michigan study, it is the author's opinion and recommendation that the best remedial action for this project is to remove and replace the "out-of-spec" material.

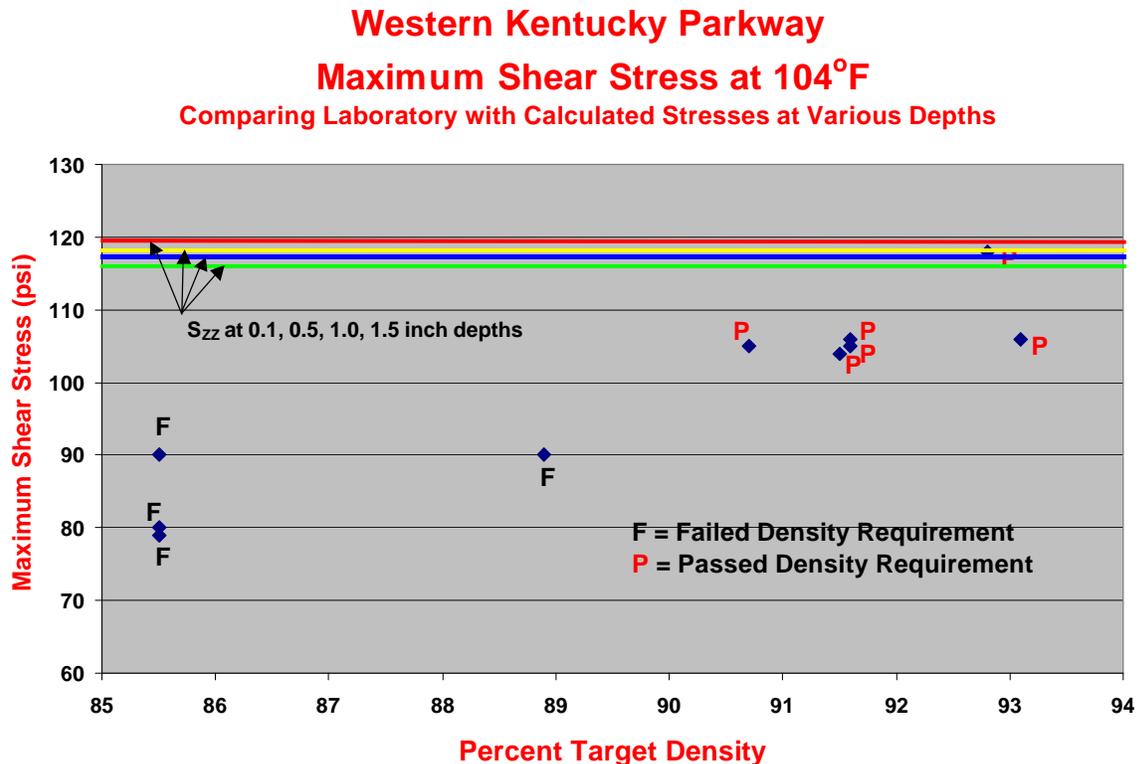
Figure 7 compares the laboratory stresses with the calculated vertical Stresses (S_{zz}). Again, the vertical stresses are all greater than the shear strength obtained from the laboratory tests. This also indicates that rutting or consolidation in the wheelpath may be a problem.

Figure 7. Comparing Laboratory Stresses with Calculated Vertical Stresses.
